*Learn from the mistakes of others; you'll not live long enough to make them all yourself . . . Issue 4/2004*

## VFR Flight Into Adverse Weather— Collision With Terrain

On June 6, 2002, a Cessna 182P was on an afternoon flight from Abbotsford, B.C., to Calgary, Alta. It failed to arrive at its destination. Emergency locator transmitter (ELT) signals were detected and the wreckage was located 17 NM northeast of Hope, B.C., at an elevation of 4 048 ft above sea level (ASL). The aircraft was destroyed. The four persons on board were fatally injured. This synopsis is based on the Transportation Safety Board of Canada (TSB) Final Report A02P0109.

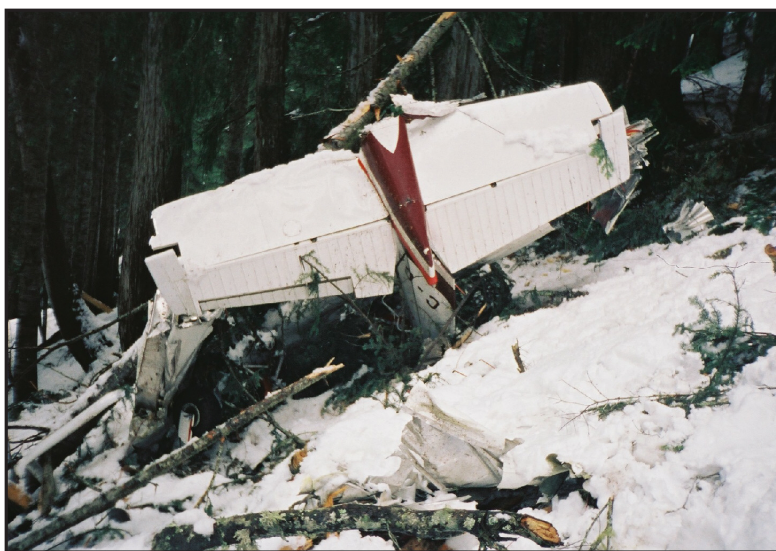
The wreckage was found on a heavily wooded, west-facing 45° slope. This site is about 1 NM south of the direct track from Abbotsford to Revelstoke. Tree damage and contact markings showed that the aircraft's flight path was mainly vertical at the time of impact. The wreckage was examined for pre-impact defects and none were found.

*Analysis*—Information from the three BC MOT avalanche weather stations and reference to the Coquihalla toll booth surveillance video indicate weather conditions at the time and place of the accident were probably much worse than forecast. The ceiling was probably lower than the forecast 6 000 ft ASL and the freezing level very close to the surface, around 4 000 ft ASL. In the area of the accident site, the pilot would have encountered rising terrain. He would also probably have encountered a lowering ceiling, likely forcing him to descend below his cruising altitude of 5 000 ft ASL in order to maintain VFR flight. Near the base of the cloud, he may have encountered turbulence, snow, and airframe icing. But he would have had very little room to descend, as the terrain in that area is relatively high, with no less than five mountain peaks ranging in elevation from 6 009 to 7 088 ft ASL, located within a 10 NM radius of the accident site.

The aircraft's flight path was mainly vertical at the time of impact, indicating the aircraft was not under control. The severity of the damage and the angle at which the aircraft contacted the terrain indicates the aircraft was likely in a spiral dive at impact, not in a stalled condition. As indicated by the last GPS-recorded aircraft position and the accident position, the aircraft was travelling southward prior to impact. The fact that the fuselage was pointing 330° may be indicative of the aircraft being in a spiral dive. The most likely scenario to account for this accident involves a known phenomenon encountered by pilots flying in mountainous terrain. The high ground obscures the natural horizon and, in this occurrence, the difficulty in seeing the horizon would be exacerbated by the low cloud.

When he encountered rising terrain and lowering cloud, the pilot probably lowered the aircraft's nose to avoid entering cloud and started a turn to reverse his course. Because no horizon would be visible when looking outside the aircraft, the only way to maintain control during this turn would be by reference to flight instruments. For unknown reasons, the pilot lost control of the aircraft, and because of the relative proximity of the terrain, the aircraft struck a tree before the pilot was able to recover control.

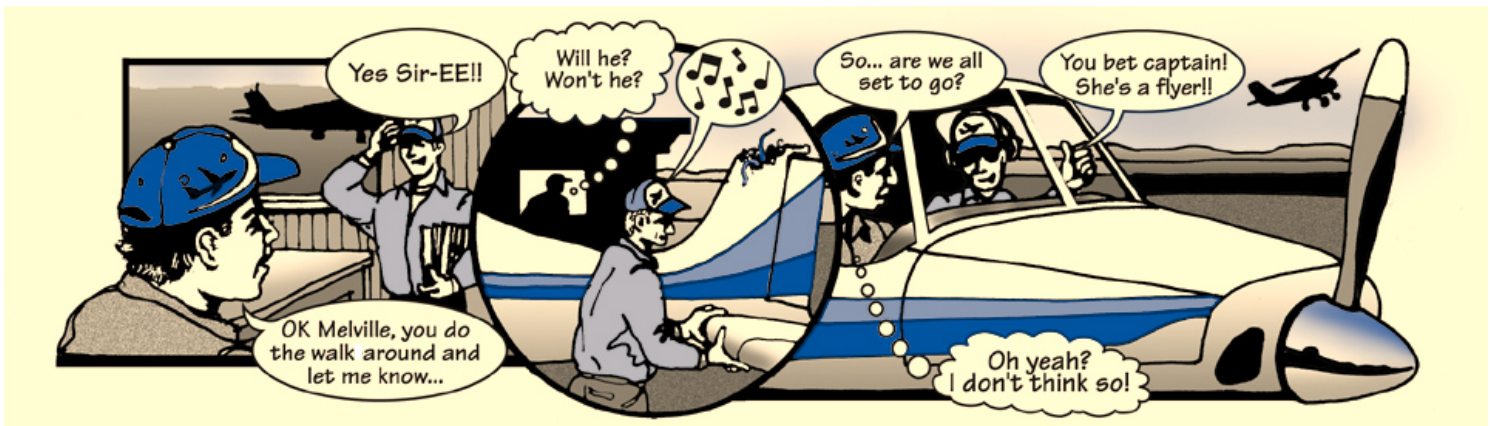
A customer rented a Piper Cherokee 140 at the school where I taught flying, and taxied it under the wing of a McDonnell Douglas DC-9. It didn't fit. The trailing edge of the DC-9's aileron neatly sliced through the top of the 140's rudder. The pilot must have felt a jerk, accompanied by the sound of ripping fibreglass, but he didn't stop. He continued to the runway, took off, flew back to our base and parked the Cherokee on the flight school ramp. He paid for the flight without mentioning the damage.

eyes and looked again when he saw the top of the rudder. Wires for the missing rotating beacon and rear navigation light hung over the jagged edge.

Several things happened over the next hour. The damage was reported to the flight school's chief mechanic. The receptionist juggled the bookings so that the instructor could have another aircraft. The rest of that lesson

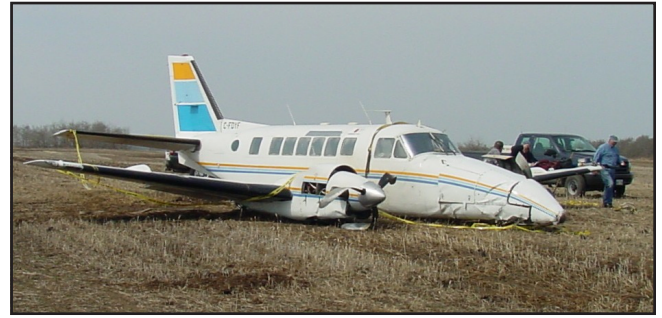
1. During flight, the horizontal stabilizer trim actuator worked free of the mounting structure, and as a result, the flight crew lost pitch control of the aircraft.
2. During replacement of the horizontal stabilizer trim actuator, the upper attachment bolts were inserted through the airframe structure but did not pass through the upper mounting lugs of the trim actuator.
3. The improperly installed bolts trapped the actuator mounting lug assemblies, suspending the weight of the actuator and giving the false impression that the bolts had been correctly installed.

4. Dual inspections, ground testing, and flight testing did not reveal the faulty attachment.
